## Vehicle Inspection form

| OSCE – Plate | Type | Model |
|---|---|---|
| OSCE 040 PA | Mitsubishi | Pajero 2.8 GL |
| ChNo:<br>JMYHNV360YJ001079 | Engine-No:<br>4M40DC9731 | Mileage:<br>118,200 km |

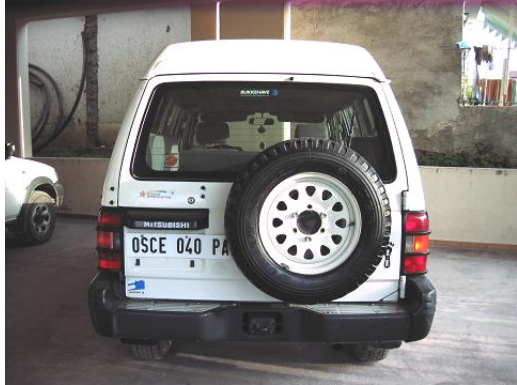
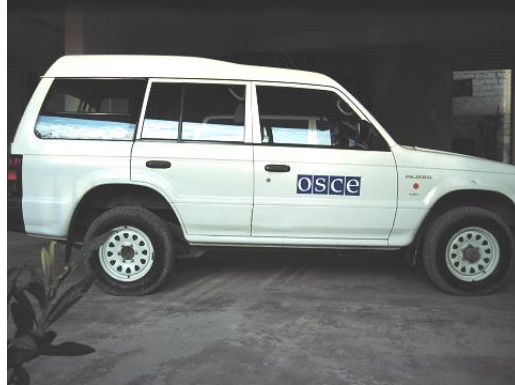
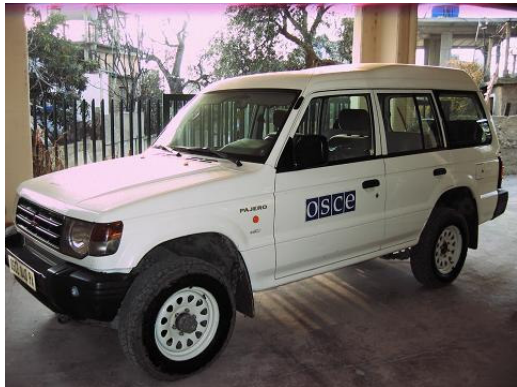
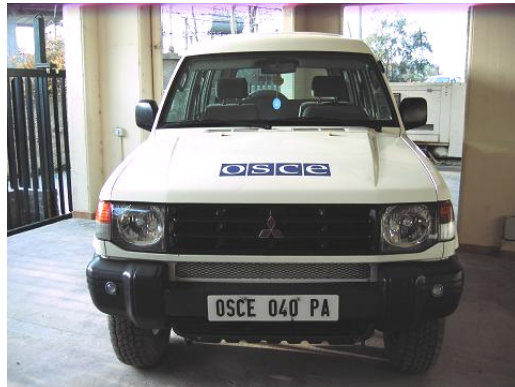
| Gearbox: Ok | Body: See photos above |
