VEHICLE INSPECTION FORM (to be finalized based on the actual number and type of vehicles)

OSCE 240 MS

N	lumber: OSCE 240 MS	Model/Make: Mitsubishi	Type: Pajero 2.8 GL
	Ch-No:	Engine-No:	Mileage:
	JMYHNV360YJ001049	4M40DC9270	120870 km

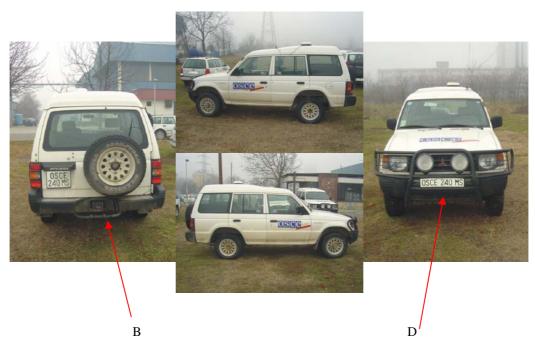
Remarks: Broken rear step; Damage under the front grill guard (bumper)

Engine:	Average	Interior:	Poor
Gearbox:	Good	Body:	Good
Brakes:	Good	Tyres:	Good
Suspension:	Average
