ACTIONS TAKEN FACING A MAJOR MARITIME AND COASTAL OIL SPILL INCIDENT

THE PRESTIGE INCIDENT

TURKMENBHASY – MARCH 10th – 11th, 2008

**RESPONSE AND REMEDIATION OF THE “PRESTIGE”
(LESSONS LEARNED)**

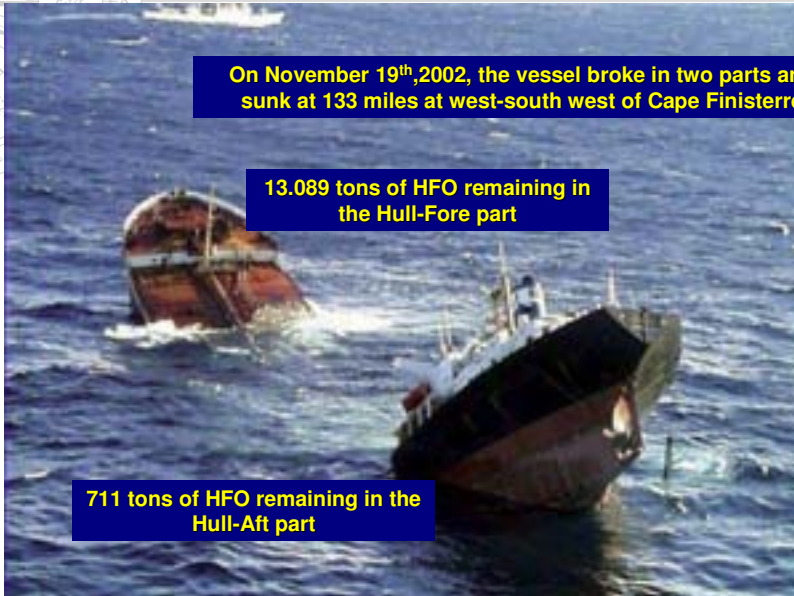
On November 19th, 2002, the vessel broke in two parts and sunk at 133 miles at west-south west of Cape Finisterre

13.089 tons of HFO remaining in the Hull-Fore part

711 tons of HFO remaining in the Hull-Aft part

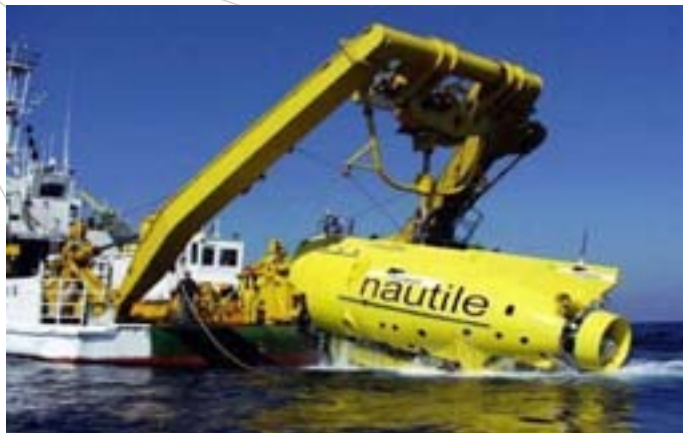
Prestige wreck: overview of the operation leading to recover 14000 tons of oil sunk at 4000 meters deep

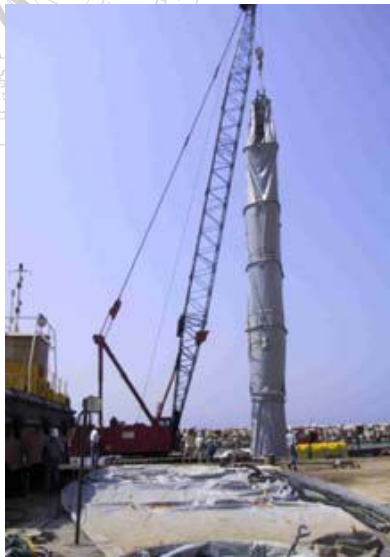
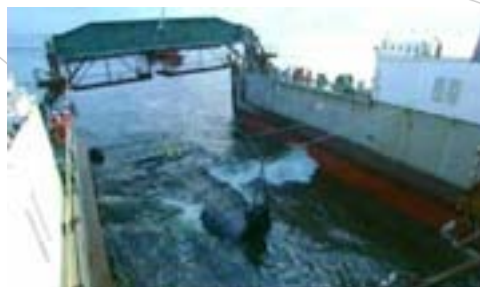
Summer 2003 – Extraction trials with flexible bags

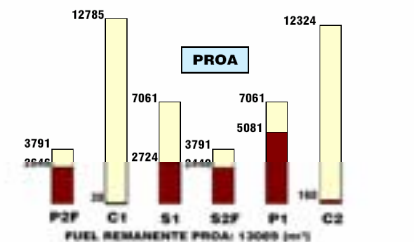
FUEL REMANENTE: 13800(m³)

13.089 tons of HFO remaining in the Hull-Fore part

711 tons of HFO remaining in the Hull-Aft part

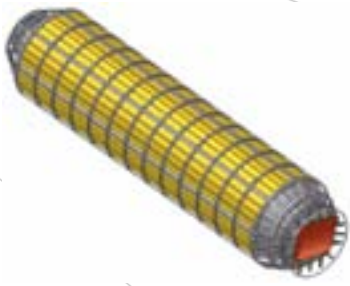
Shuttle afloat and towed

► The shuttles are cylinder-shaped rigid structures, made of 6mm thick aluminium, and with transversal and longitudinal stiffeners.

- Length: 23,00 m
- Outer / inner diameter : 5,40 / 4,70 m
- Volume: 350 m³
- Weight / Buoyancy: 18 / 1 Tm.

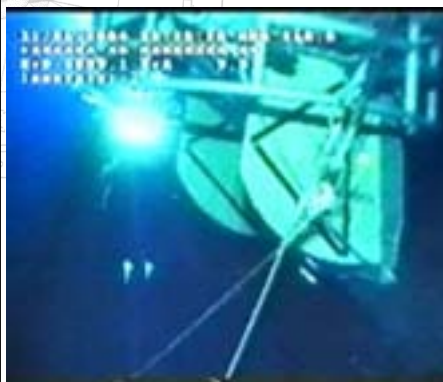
Shuttle lower door opened, over the extraction valve

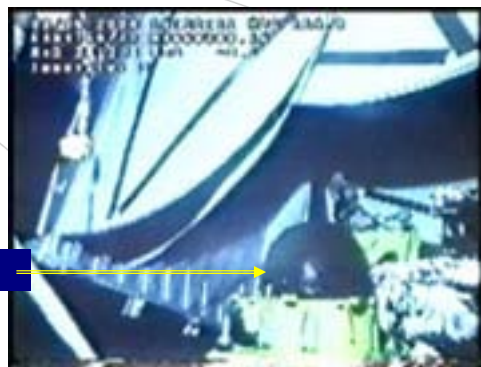
Oil begins to flow through the valve

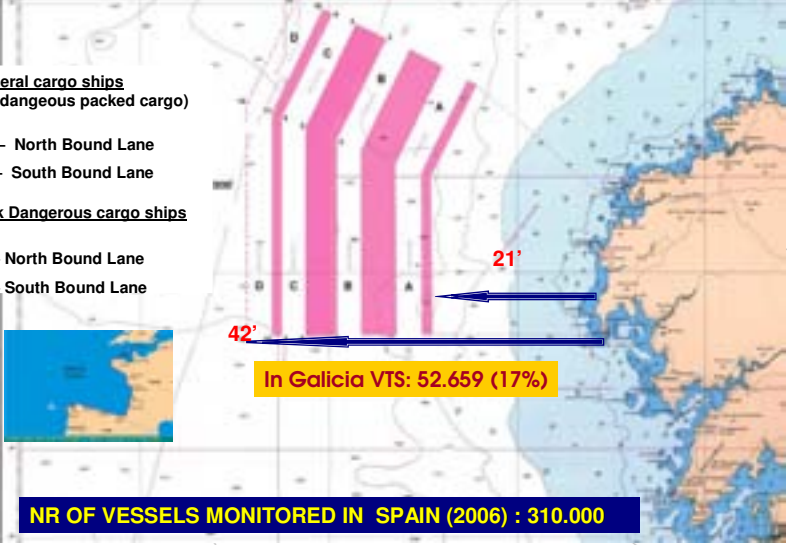
Offshore Shifting of the Finisterre Traffic Separation Scheme (TSS)

General cargo ships
(or dangerous packed cargo)

A – North Bound Lane
C – South Bound Lane

Bulk Dangerous cargo ships

B – North Bound Lane
D – South Bound Lane
